**PRESERVATION PLAN FOR
SELECTED SITES AT NU'ALOLO KAI,
NĀ PALI COAST STATE WILDERNESS PARK
DISTRICT OF WAIMEA, KAUA'I**

**STATE OF HAWAII
DEPARTMENT OF LAND AND NATURAL RESOURCES
DIVISION OF STATE PARKS**

June 2007

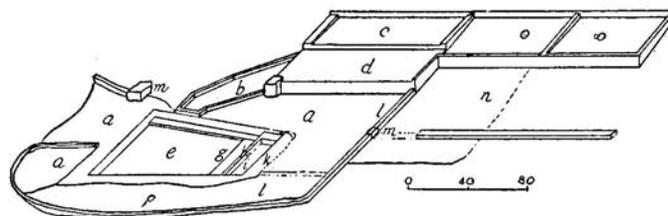
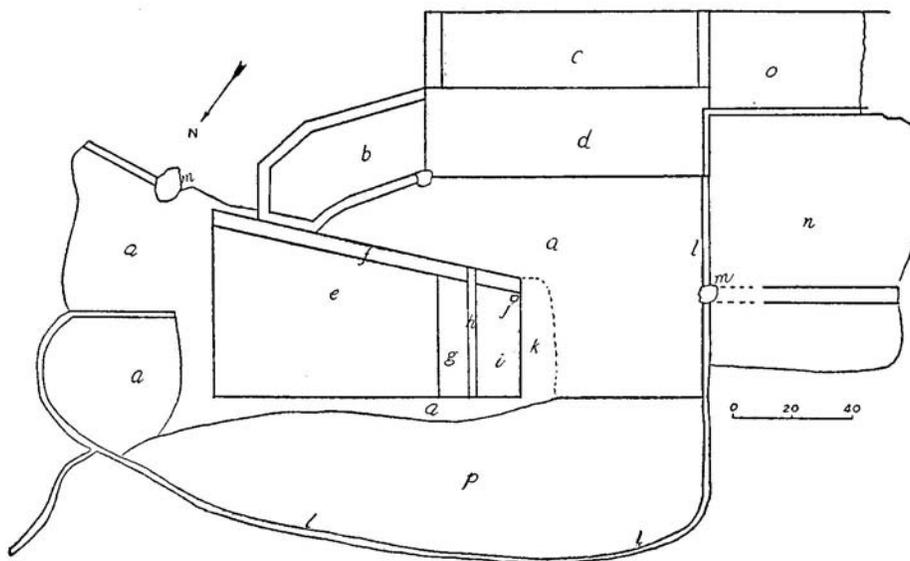
FIGURE 2. Sites in Nu'alolo Kai recorded by Wendell Bennett (Bennett 1931).

FIGURE 54.—Plan of house site on Nualolo flats, Site 196: *a*, path to the sea; *b*, enclosure 10 by 42 feet; *c*, *d*, and *e*, dirt-paved platforms respectively 20 by 24 feet, 20 by 42 feet, and 25 by 27 feet; *f*, platform 24 feet by 30 feet and 7 feet high; *g*, pathway and steps; *h*, platform 24 by 32 feet and 5 feet high; *i*, platform 24 by 28 feet and 4 feet high; *j*, platform continued at the back as a narrow, rising slope.

FIGURE 55.—Ground plan and perspective plan of a heiau on Nualolo Flats, Site 199: *a*, paved platform level with surrounding ground; *b*, unpaved inclosure with walls 2 to 3 feet high and 4 feet wide; *c*, paved platform 25 by 93 feet; *d*, paved platform 29 to 93 feet; *e*, eastern section of depressed area 40 to 60 feet by 74 feet; *f*, bench terrace 1 foot high, 5 feet wide; *g*, bench terrace 2 feet high, 10 feet wide; *h*, division wall 2 feet high, 3 feet wide; *i*, western section of depressed area 12 feet by 38 feet; *j*, walled spring 2.5 feet in diameter, 2 feet deep; *k*, paved area with indefinite boundaries; *l*, wall 3 feet wide, 3 feet high; *m*, cave under rock containing bones of animals; *n*, paved area crossed by a wall 5 feet wide and 2 feet high; *o*, unpaved house sites inclosed by walls 2 feet high on the inside; *p*, sand.

Wendell Bennett, a visiting archaeologist, spent 9 months on Kaua’i in 1928, surveying as many sites as possible around the island. He spent enough time in Nu’alolo to publish in 1930 descriptions and serviceable maps of the archaeology in the eastern end of the coastal flat there (Figure 2). In addition to providing the first archaeological documentation of house sites nestled against the eastern cliffs (which had been visited and mentioned by visitors over much of the 19th Century), Bennett noted additional sites on the coastal flat and another on a ridge between these and the central channel landing.

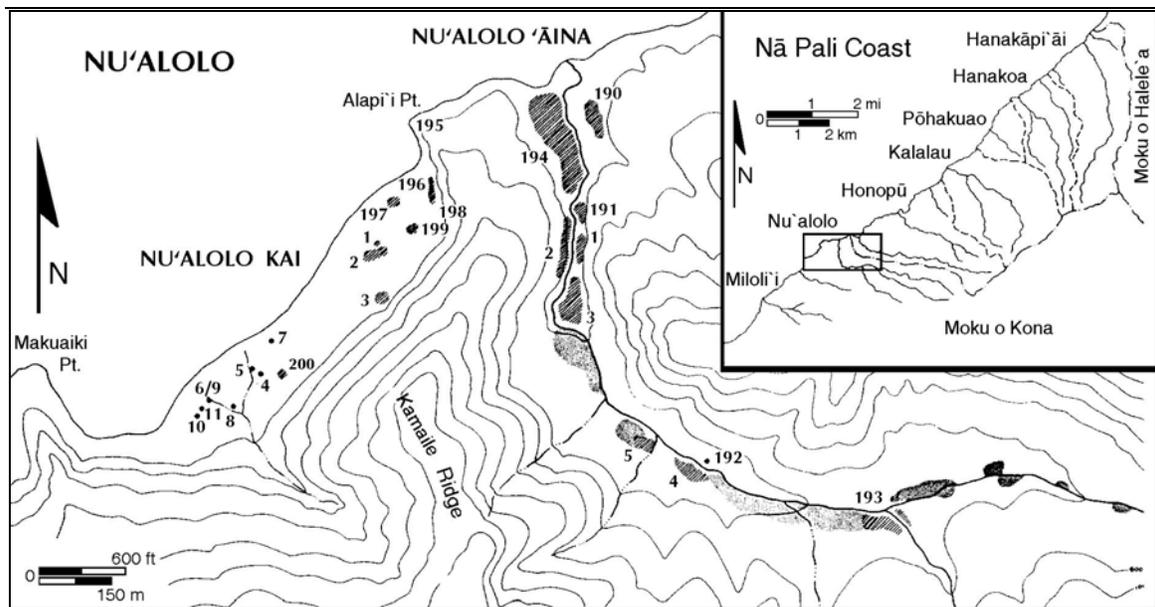
FIGURE 3. Sites in Nu'alolo recorded in 1979 (Tomonari-Tuggle 1989).

A few years later in 1979, Myra Tomonari-Tuggle, as part of a contract to locate sites throughout Nā Pali Coast State Park and develop a management strategy, visited Nu'alolo again. Synthesizing previous archaeological work, historical accounts, and knowledge from Kikuchi and other knowledgeable locals, she was able to situate Nu'alolo Kai in relation to its neighbors, the coast in general, and in the sweep of history. Previously documented sites were relocated, and an additional 11 were discovered in Nu'alolo Kai, including NUK-1, a complex with an estimated 10-15 mounds and platforms in excellent condition and interpreted as burials, which is now known as Site 7150 (Tomonari-Tuggle 1989:93). The remaining 10 sites, most of them on or immediately below the talus slopes on either side of the drainages that occasionally flow into the channel through the reef (in other words, west of the more obvious site complexes at the eastern end of the coastal flat), included platforms, terraces, mounds, and buried deposits exposed in erosional cuts. Though some were in reasonably stable condition, those near the drainage and close to the coastline were considered at risk.

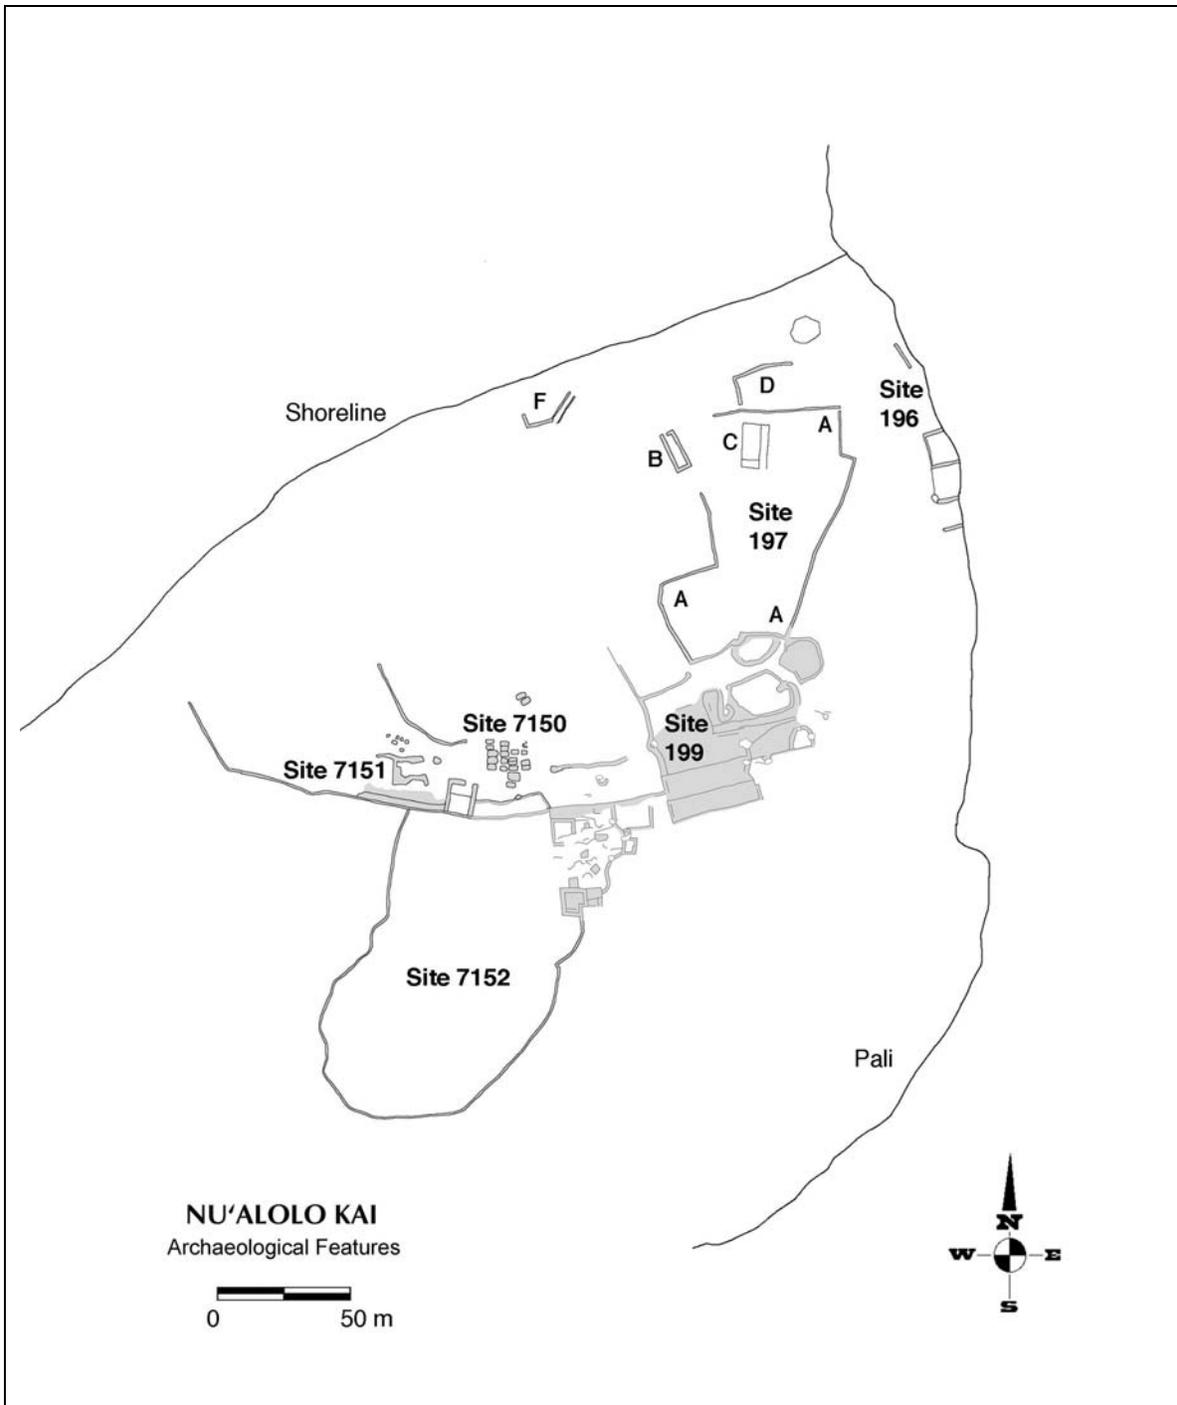
FIGURE 4. Overview of sites at eastern end of Nu'aloalo Kai.

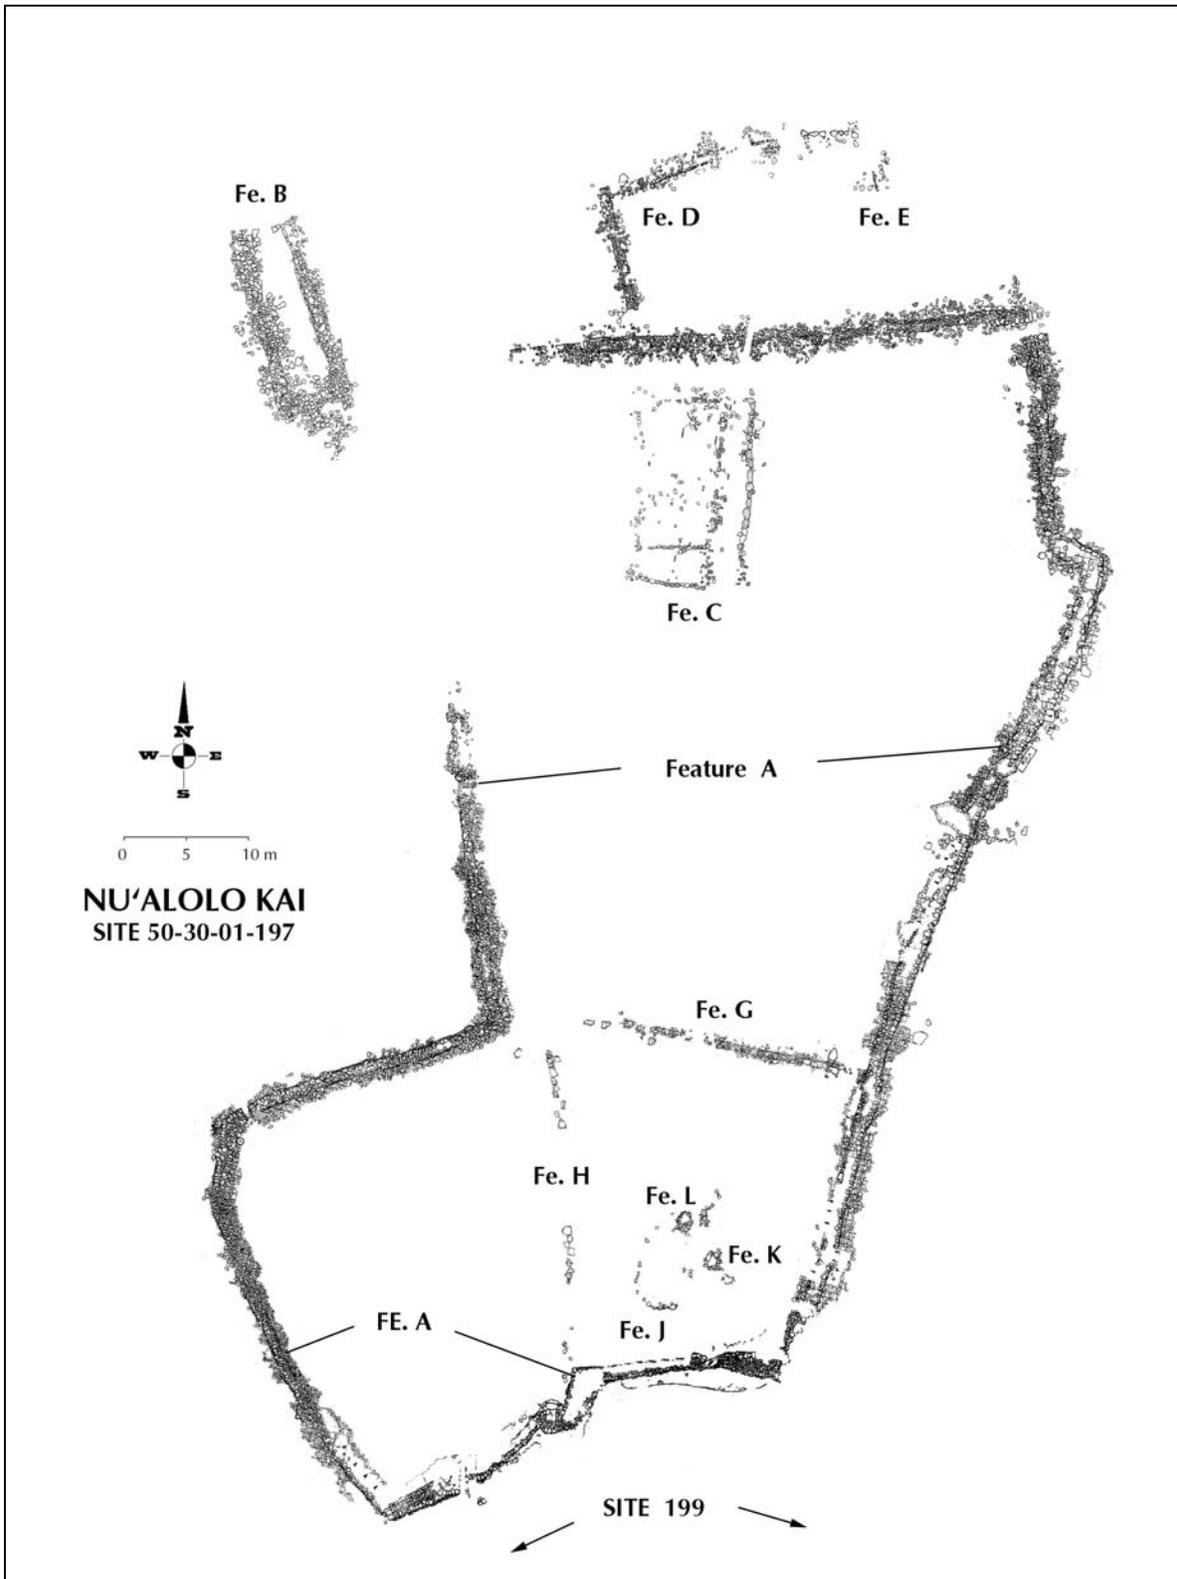
FIGURE 5. Site 197 Surface features overview.

This feature was described as a large enclosure by Yent (1983) covering approximately 50 (E-W) by 80 (N-S) meters. Irregularly shaped overall (Figure 5), construction style and condition varies throughout Feature A (Figures 6-11), which could be more aptly described as a series of wall segments which once composed

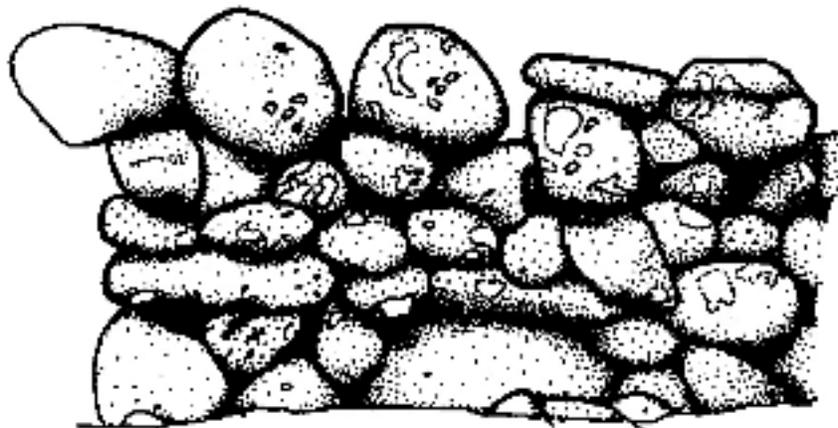
FIGURE 6. Site 197:A. Detail of south exterior/*mauka* facing where 197 and 199 meet. All stones are rounded and waterworn. Note base course of boulders interspersed with cobble fill, second course primarily of flat boulders, 3rd and 4th courses of cobbles, and 5th course of small boulders.

The southern wall, 36 m in length, is constructed of predominantly waterworn medium sized boulders, neatly stacked, ranging from 50-80 cm in height and typically 60 cm or 3 courses high and a meter in width. Three pathways cut through the southern wall (see below). The wall in this section contains a couple of obtuse-angle bends, possibly related to features of the intricate ceremonial complex (Site 199) immediately adjacent on the south. A portion of this wall serves as the *makai* wall of Site 199, an enclosure positioned above 199:E (a low-lying feature variously interpreted as a *lo'i* cultivation pond or pool), and at a similar elevation to a paved enclosure (199:Q). The shared wall segment exhibits a *mauka* face with a stylistically distinct appearance: one course of boulders as a foundation, atop which are 2-3 courses of waterworn cobbles, above which is a single course of larger stones. Higher still, collapse has affected the wall, but remnant sections and the toppled stones suggest that another 2 courses of cobbles were capped with another single course of larger stone.

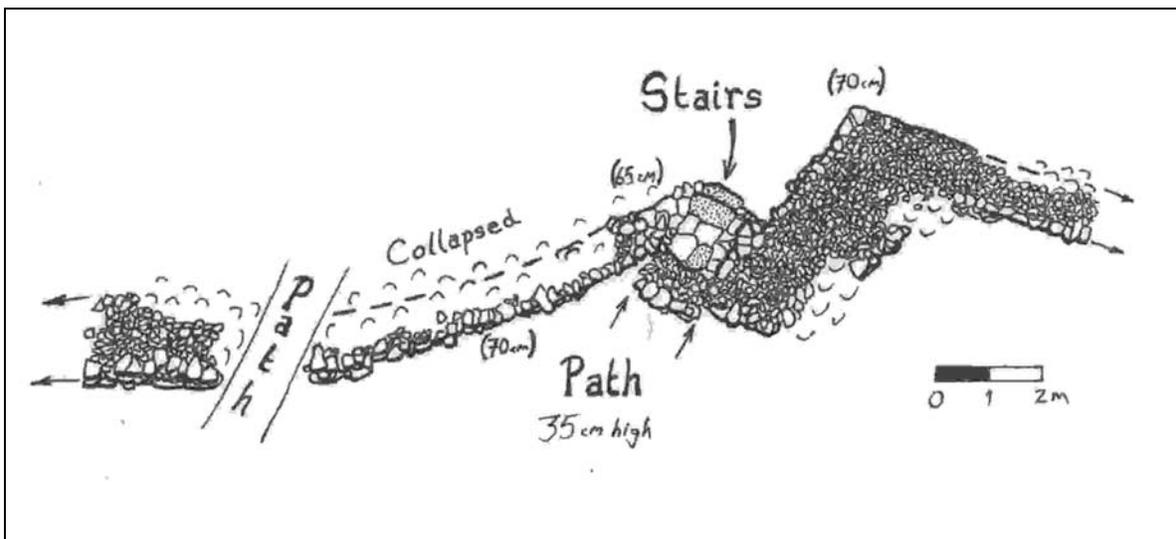
FIGURE 7. Site 197:A. Detail of south wall planview showing collapsed and constructed gaps.

Three locations on the 197:A south wall also have crossings. Neither has a complete opening all the way to ground level, and instead they consist of low areas in the wall where it is easy to walk across. While it is possible that two of these

represent sections of collapse or informal trails used by campers and goats (these appear near the east and west ends of the south wall), the third represents intentional construction. The latter interpretation stems from the use of sandstone slabs, set horizontally to form steps whose highest elevation is just half that of the adjacent wall sections (Figure 7). In addition, this passage corresponds to a discontinuity in the Feature A wall. To the west, the wall is the common form—faced on either side with a core fill—and size—1 m wide at the base and 70 cm high. East of the passage, the wall is oriented differently, leading to a corner, and 2 m wide; this portion appears to be the exterior of the enclosure in Site 199. These features may date to a period after active use of 199, or at least after this portion of Nu'alolo Kai was segregated from the remainder by walls, representing a pathway providing direct access from *makai* down to the water level in 199:E.

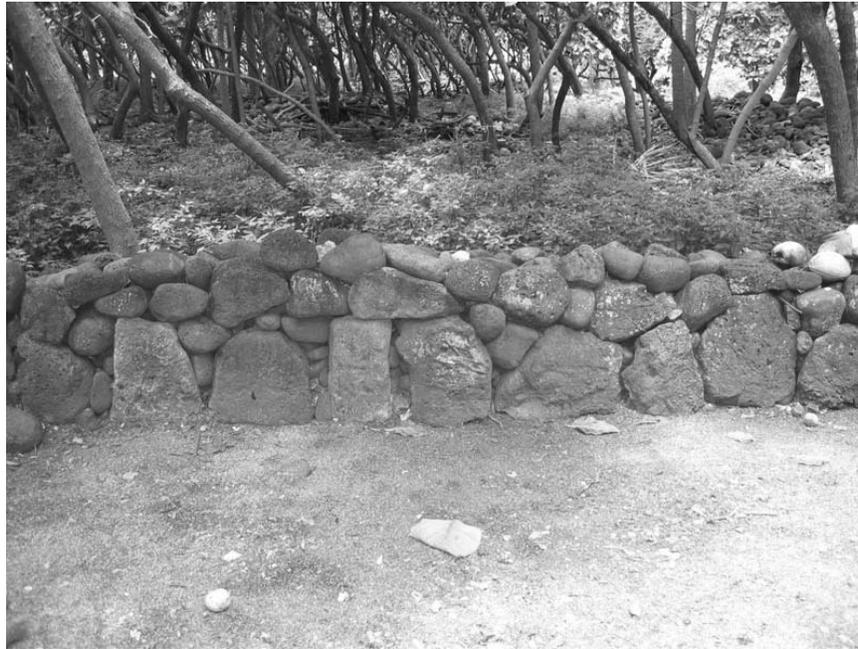
FIGURE 8. Site 197:A. Detail of north-south run of west wall, view to east of exterior.

The west and north walls include carefully set, upright laid foundation stones of subrounded basalt and subangular flat sandstone boulders on the north and west (exterior) faces of the enclosure, corresponding to the sides visible from *makai* or if approaching from the west. The opposite side of the wall (south or east, respectively) consists of finely stacked rounded-subrounded basalt boulders, and

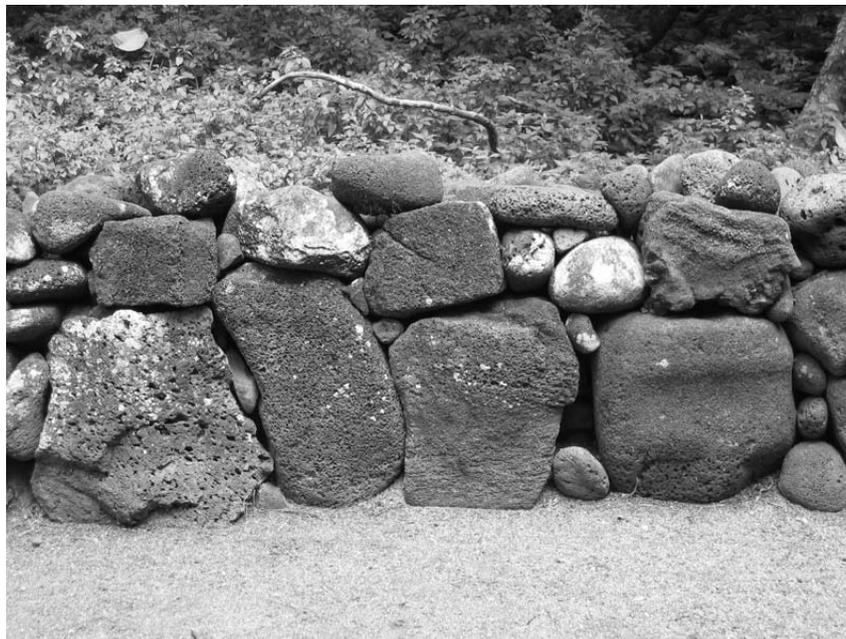
FIGURE 9. Site 197:A. Detail of north-south run of west wall, view to east of exterior.

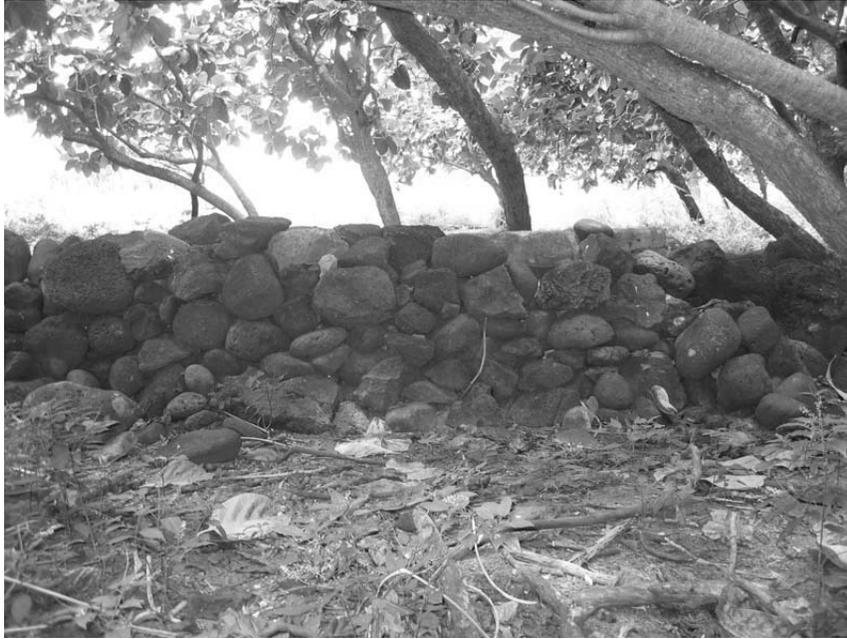
FIGURE 10. Site 197:A. Detail of east-west run of the west wall, looking *makai*/north at interior facing.

incorporates almost no beachrock and few to no uprights. As with Feature B (see below) this is a dramatic contrast. The west wall segment measures 82 m overall, and contains two nearly right-angle bends. It typically stands 70 cm or 4 courses high on the interior, and 80 cm or 3 courses high on the exterior, exclusive of the northern robbed segment. The wall averages a meter in width.

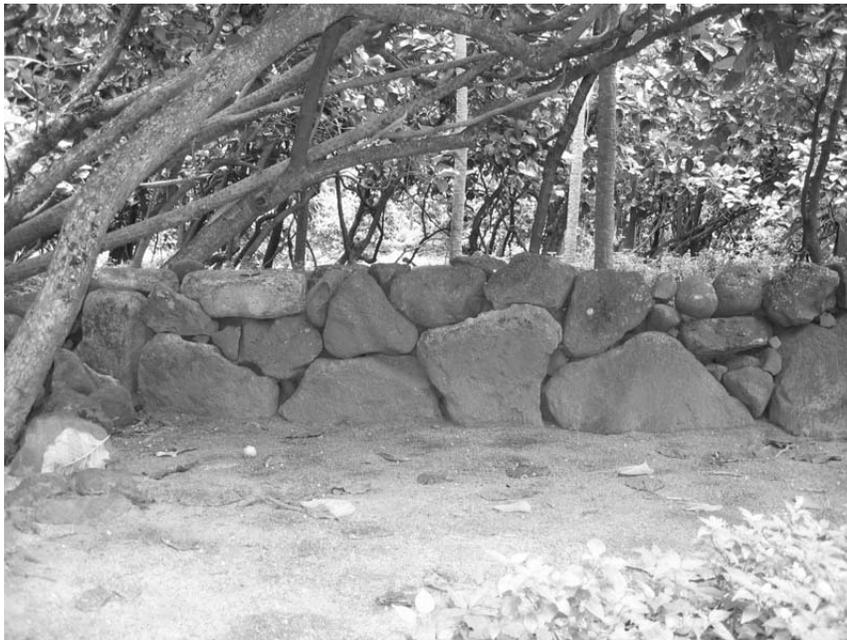
FIGURE 11. Site 197:A. Detail of east-west run of the west wall, looking *mauka*/south at exterior facing in same location as previous photograph.

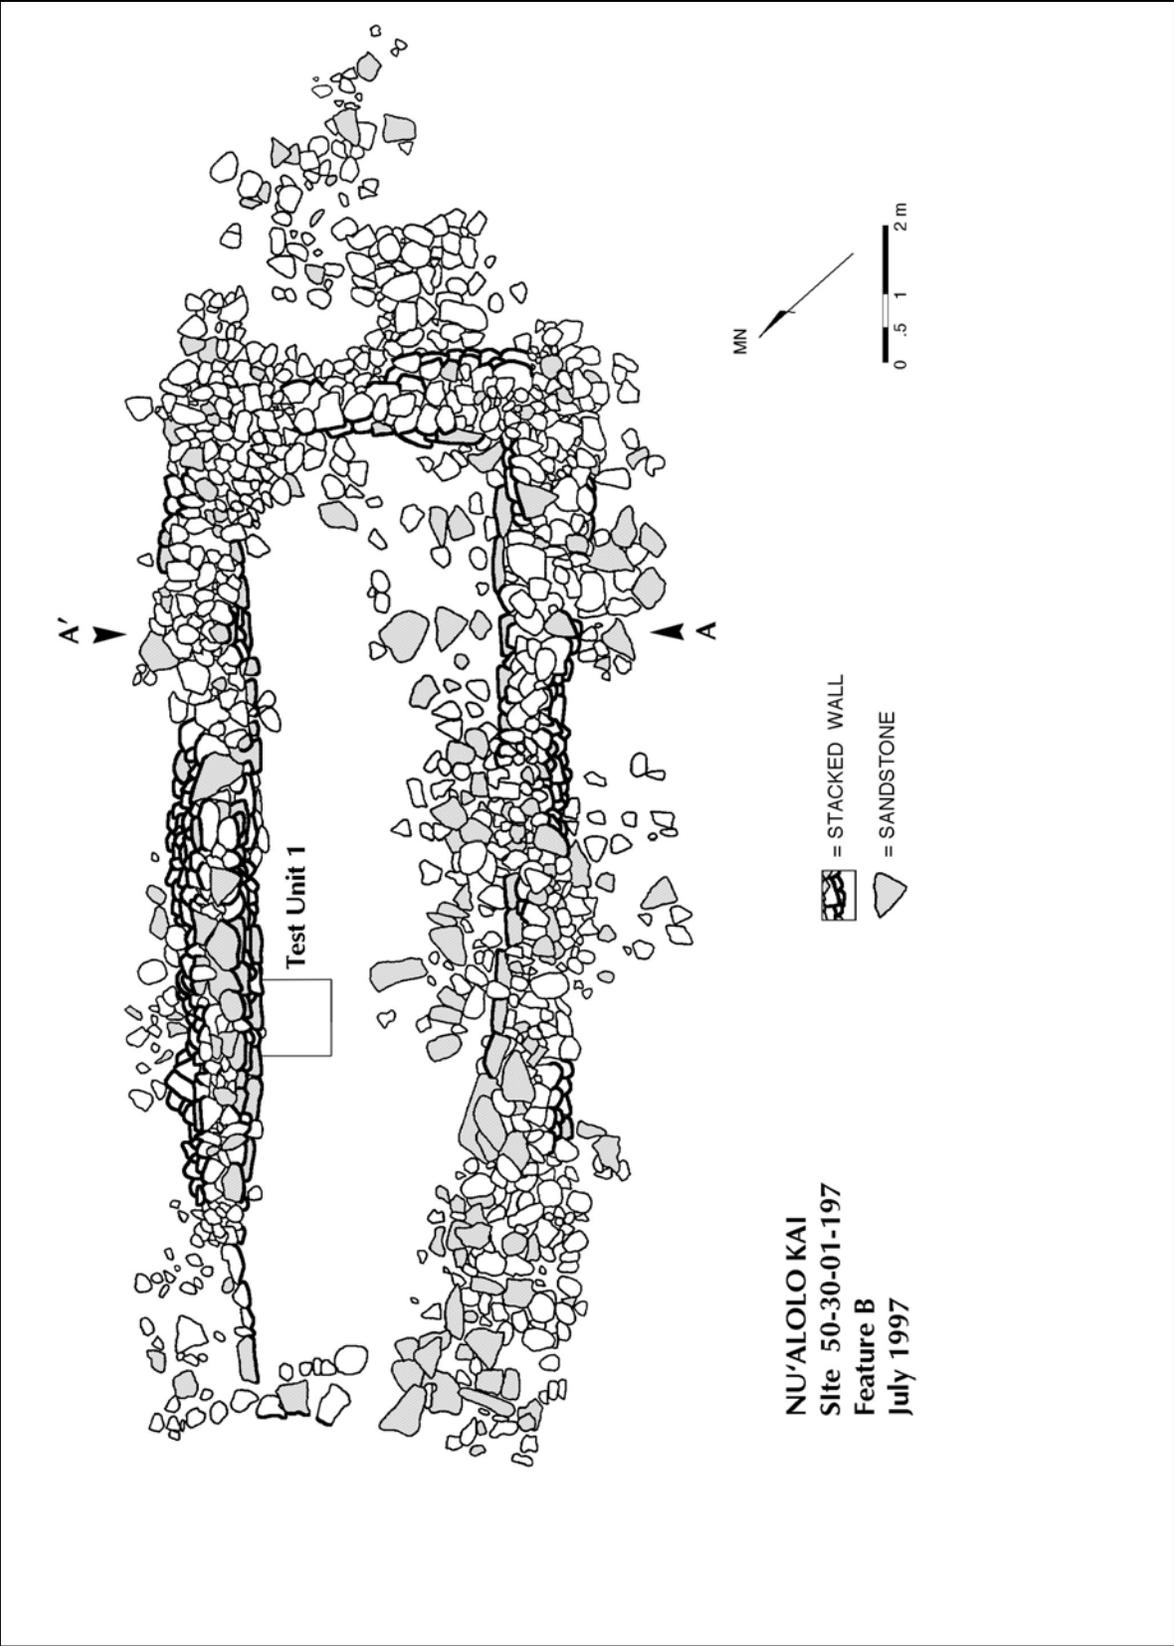
FIGURE 12. Site 197:B Planview.

Feature B consists of a long, rectangular enclosure or U-shaped feature constructed of stacked sandstone beachrock and waterworn to subrounded basalt boulders and cobbles. The walls are core-filled, predominantly with basalt boulders and cobbles. Due to collapse of the feature, and possible post-abandonment removal of stones, it is unclear whether the feature was enclosed on the *makai* end, though several apparently embedded stones at its north corner suggest it may have been. It is of the form commonly referred to as a “canoe shed”, though others have suggested that this feature type in fact should be more appropriately referred to as an historic habitation feature. The long axis of the feature is oriented 323°, more or less perpendicular to the shoreline.

The feature measures 15.8 m by 6.5 m overall (excluding collapse), with interior measurements of 14.0 m by 3.6 m inferred from the remaining intact foundation stones. Many portions of the wall have collapsed, although remaining portions

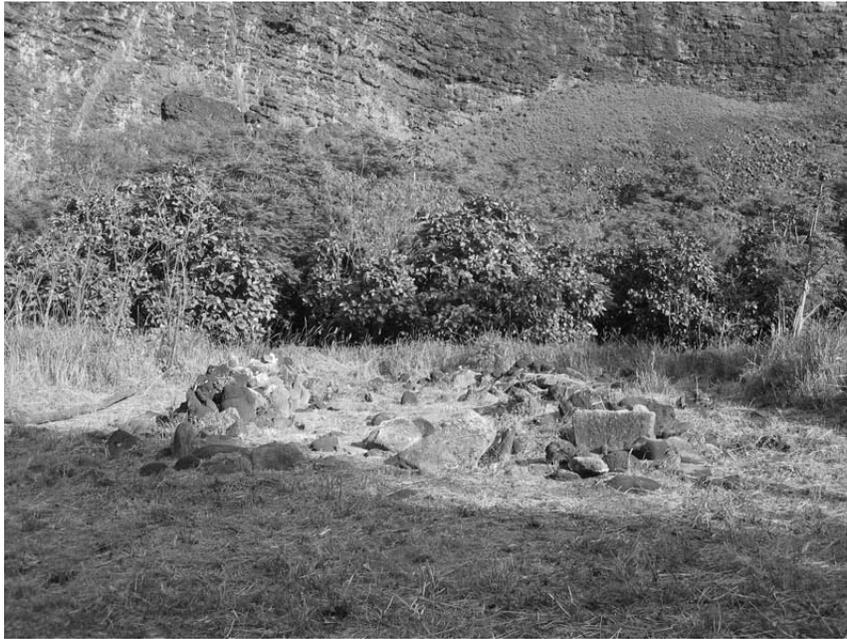
FIGURE 13. Site 197:B, view *mauka*.

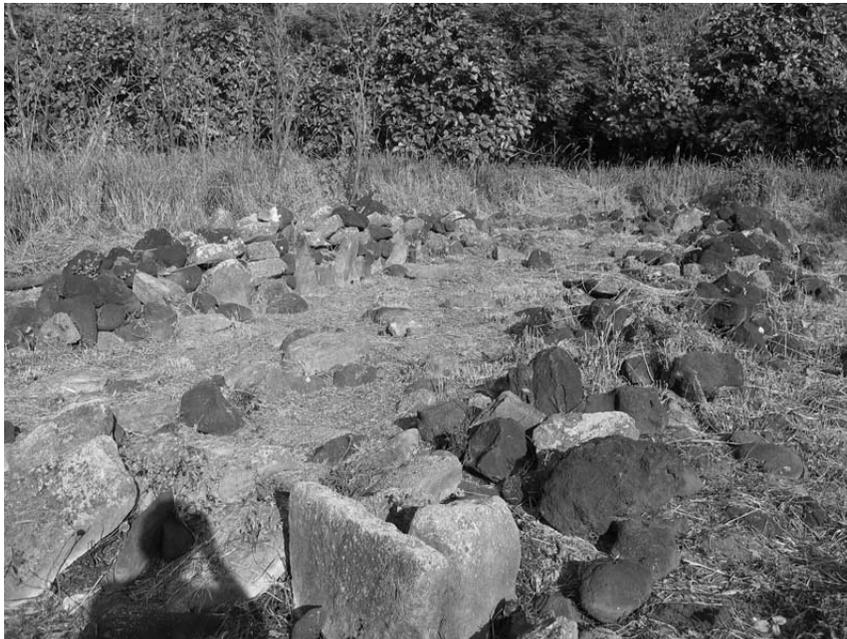
FIGURE 14. Site 197:B, view of interior with northwest corner in foreground.

There is no surface evidence that the feature’s interior was paved. Though there are a large number of scattered stones within the feature, they are concentrated adjacent to the walls where the greatest amount of collapse has occurred, indicating that they are the result of wall fall and not disturbed paving stones. Several horizontal slabs of beachrock in the *mauka* third of the feature lack the closely fit joints exposed in excavated pavements beneath Feature B and in Site 7154, and although they have not been lifted or otherwise excavated, seem not to be a part of a pavement. Their alignment, which the cross-section shows to be shared with another horizontal sandstone slab on the exterior foundation of the east

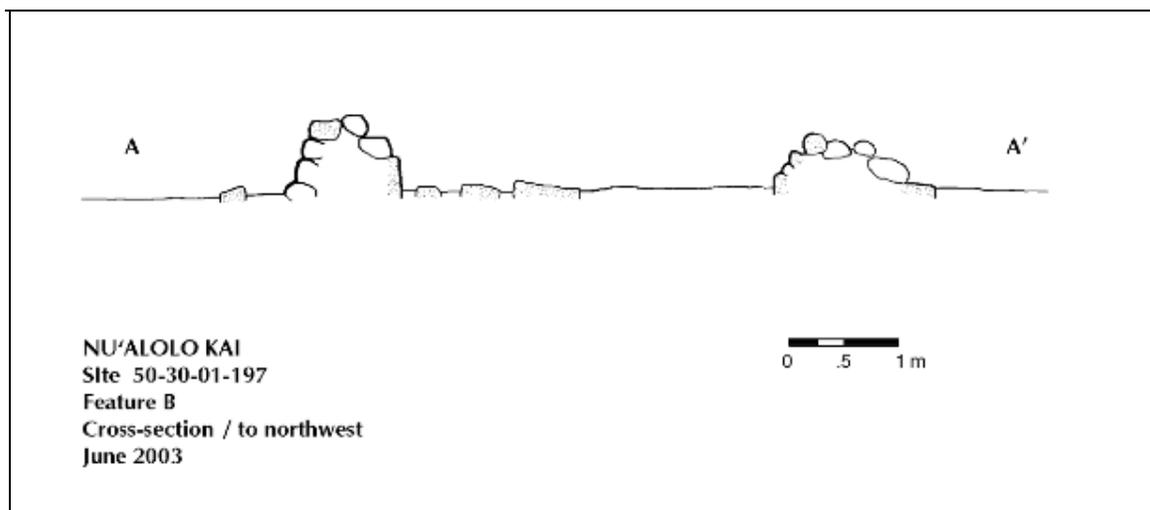
FIGURE 15. Site 197:B Cross section parallel to shore.

measure up to 85 cm in height on the northeast (more intact) wall, and up to 75 cm in height on the southwest wall, though a height of 40 cm is more representative of this side of the feature (Figure 15 – x-sec). At least one local fisherman whose family has long visited Nu‘alolo Kai has suggested that much of this collapse was as a result of the 1946 tsunami, though this cannot be proved. Modern disturbance (i.e use of the area as a campsite), as well as neglect and natural forces also have likely contributed to the current condition. Many stones strewn about the interior and exterior of the feature clearly were formerly incorporated into the walls. It does not appear that any significant number of stones have been removed from the feature, with the possible exception of the *makai* end of the northeastern wall, where no fill stones are evident. Overall, the feature is in fair to poor condition.

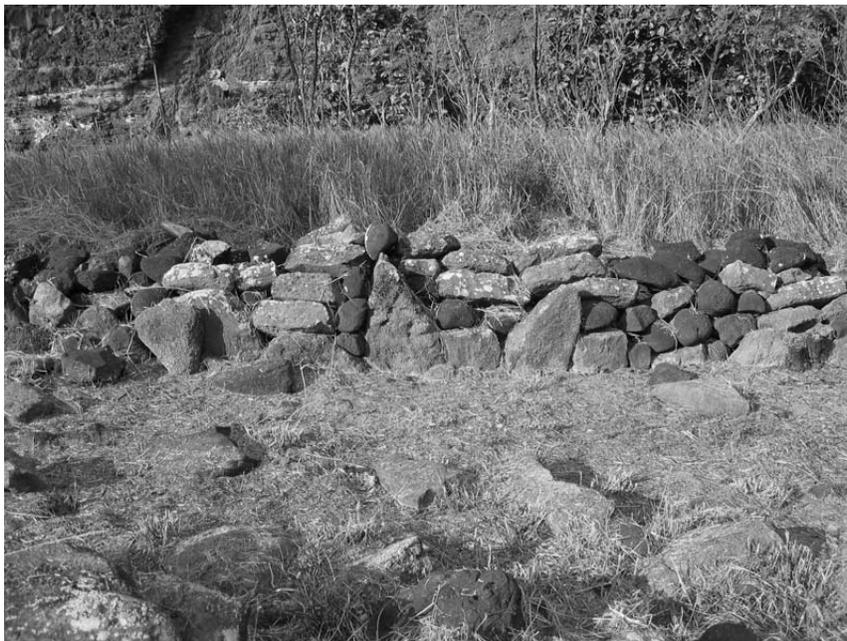
FIGURE 16. Site 197:B. Detail of east wall interior. Note upright sandstone slab foundation, and mix of horizontal sandstone and basalt in upper courses. Excavation occurred against slabs at center.

An interesting aspect of the feature is the differentiation of construction styles between the interior and exterior wall facings. On the interior, the base stones consist of deeply embedded, upright-placed flat beachrock/sandstone slabs. These are topped by horizontally laid beachrock slabs and by waterworn to subrounded

basalt boulders. On the exterior, the facing consists wholly of stacked basalt boulders, with little to no sandstone incorporated. This unique construction style shared with Site 197, Feature A, which possesses the upright slab construction on one side only, though that feature incorporates basalt as well as sandstone slabs into its base course.

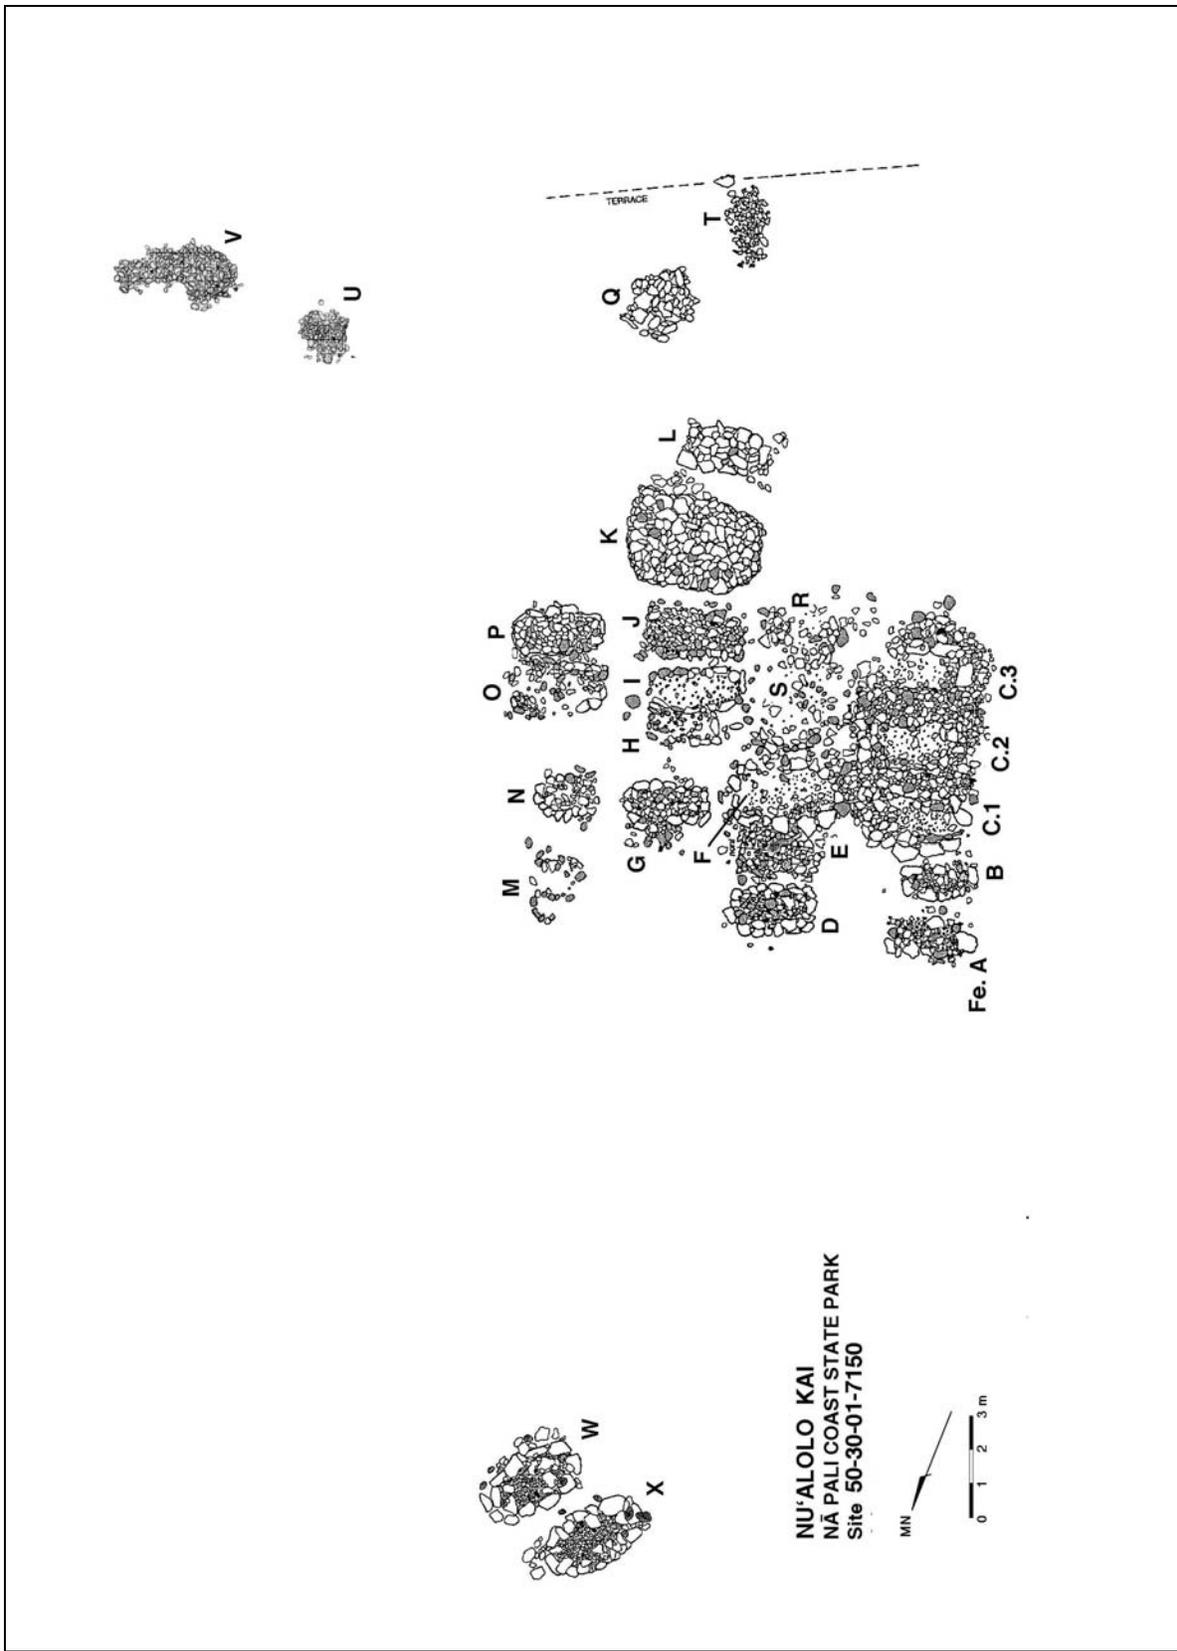
FIGURE 17. Site 7150 Overview, after Carpenter and Major 1999.

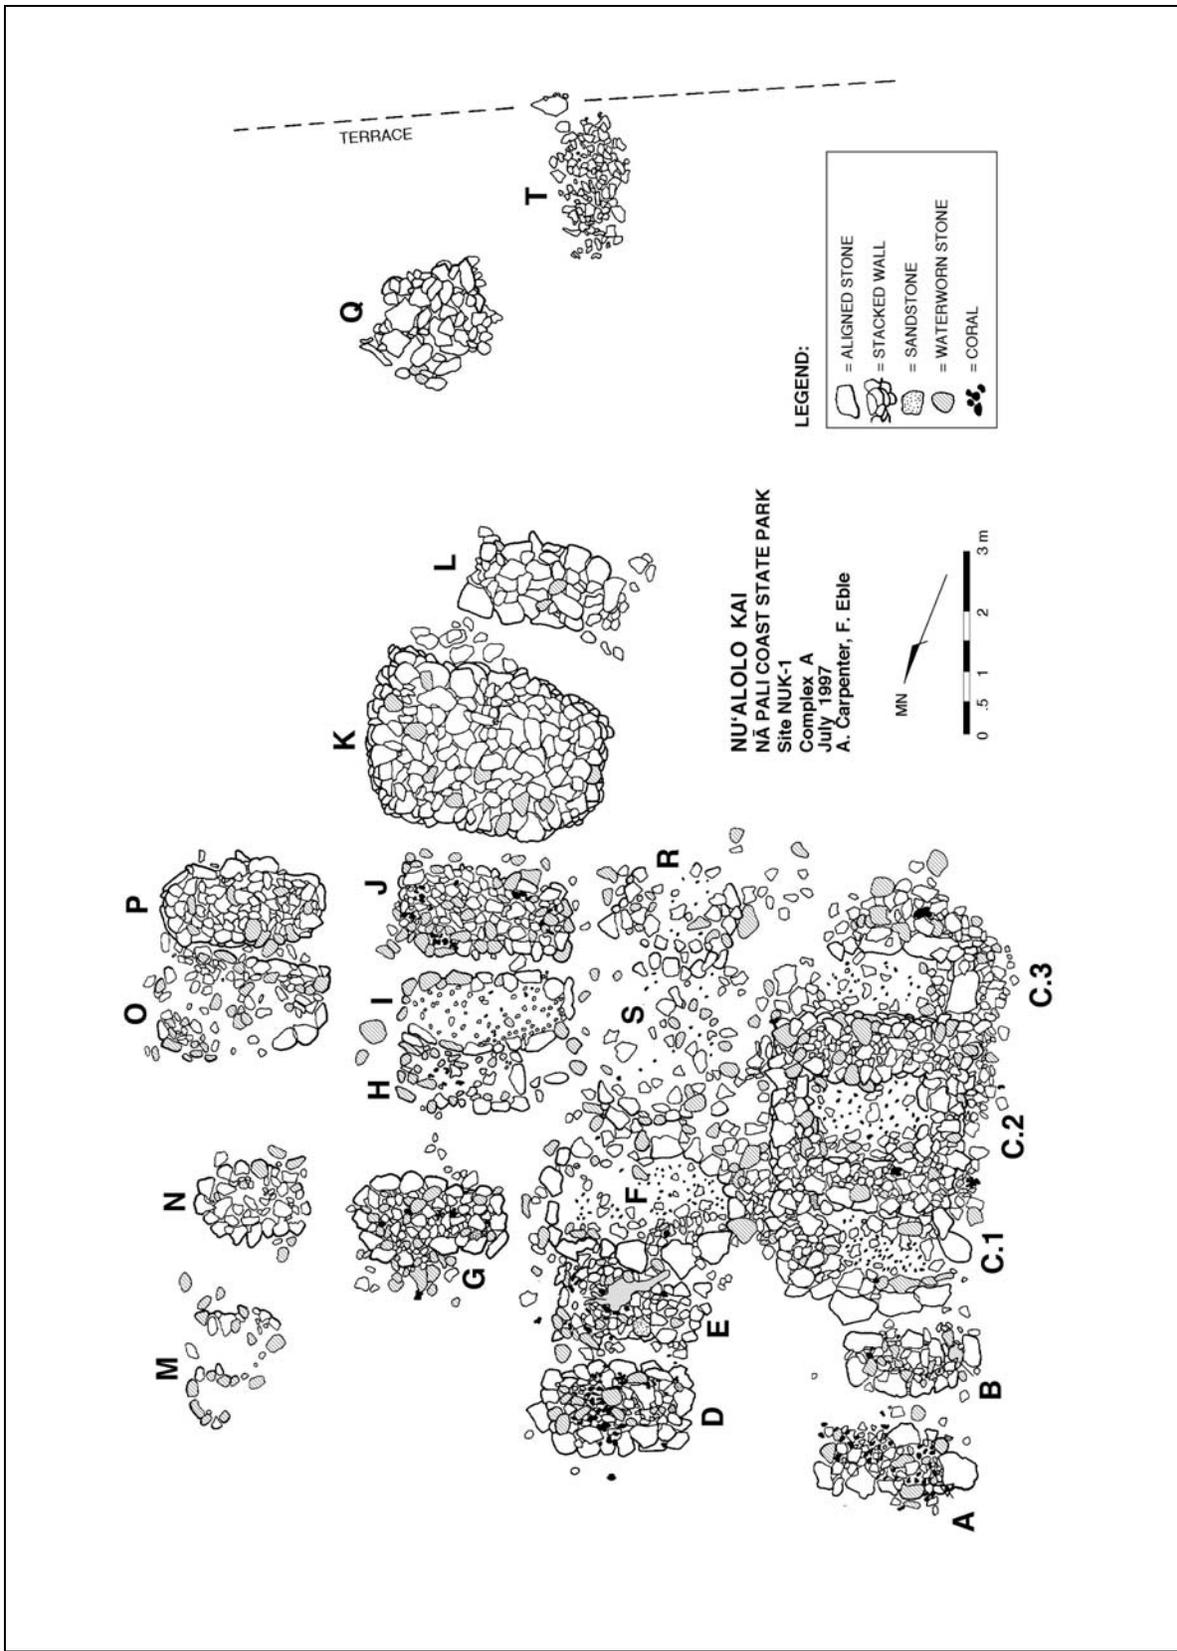
FIGURE 18. Site 7150 Main Complex, after Carpenter and Major 1999.

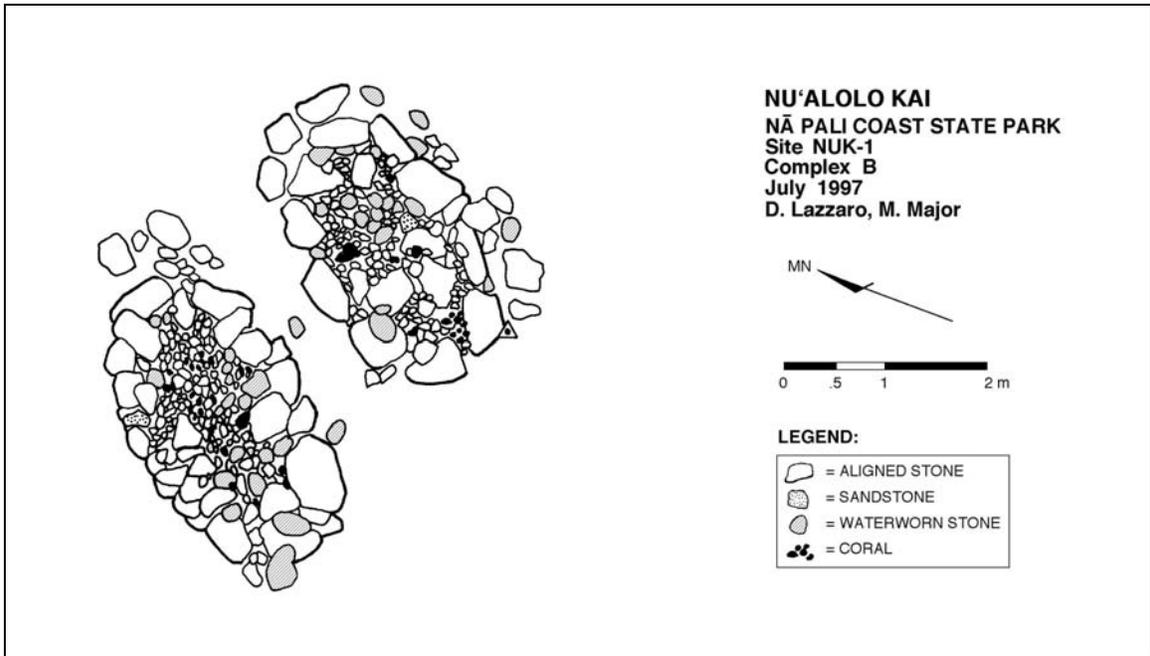
FIGURE 19. Site 7150 Outlier Complex, from Carpenter and Major 1999.

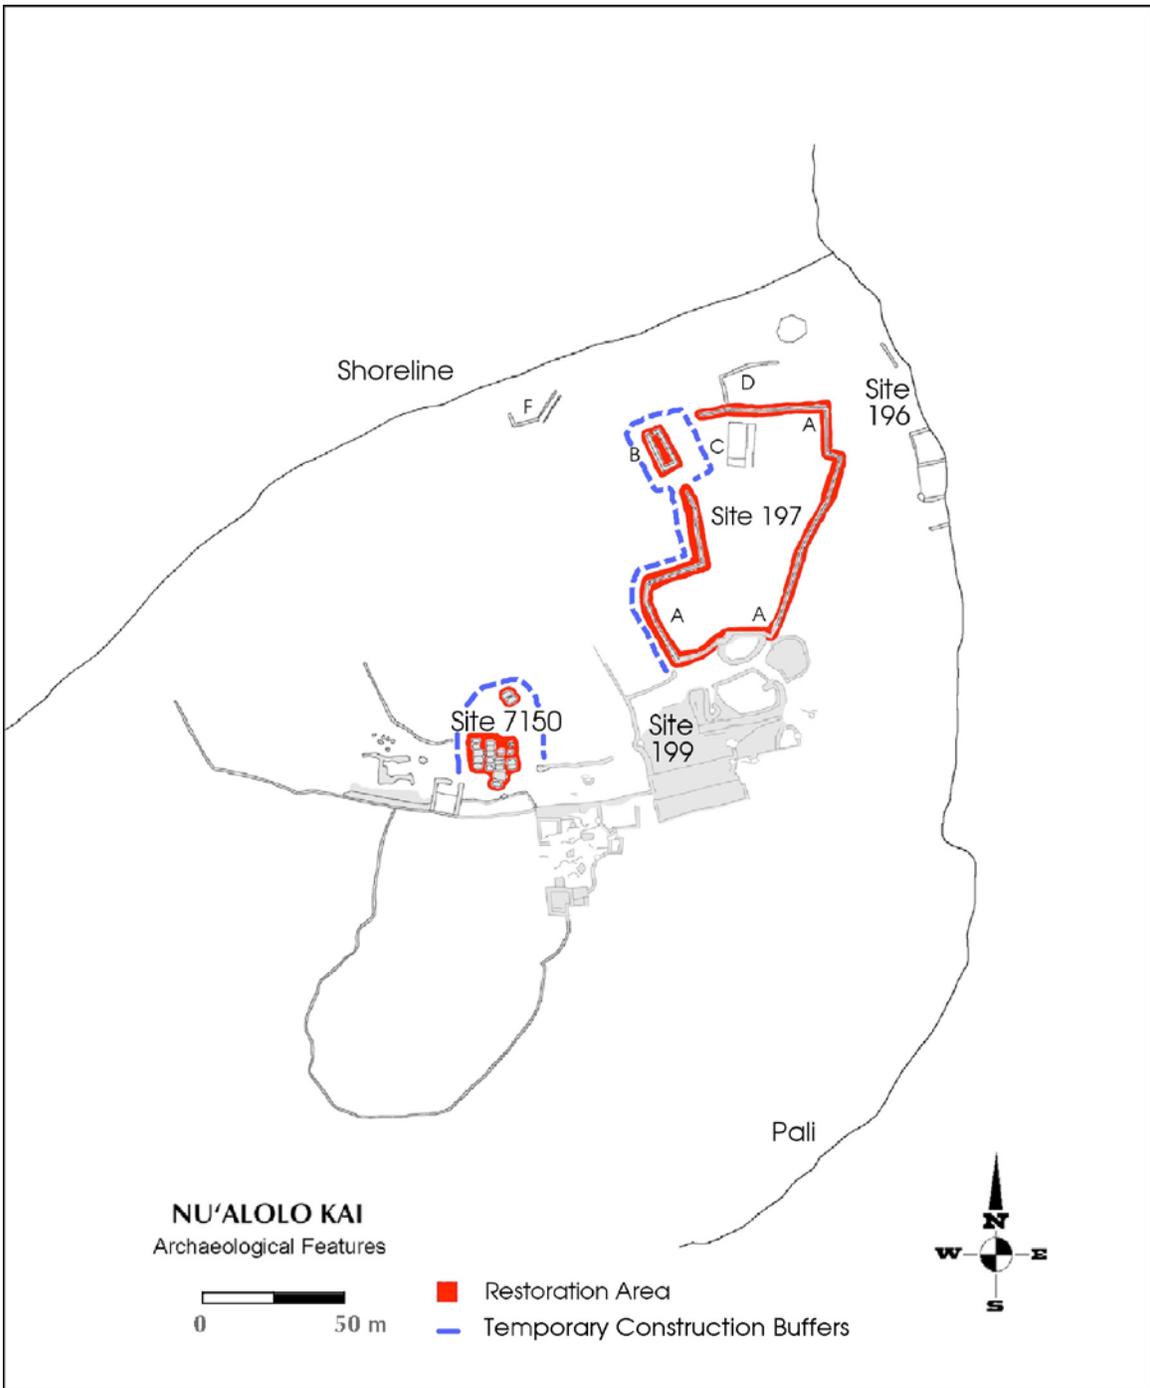
FIGURE 20: Proposed construction buffers.

Figure 20 depicts the initial buffer that will be established for restoration work. It will be established on the trail side of features only – there is no need completely encircle features due to the nature of the terrain and visitation patterns. The buffers shown also correspond to the site areas intended for initial restoration—should other areas of Site 197, Feature A be undertaken, appropriate buffers will be established. The varying distance from the surface feature is intended to establish a work zone in which tools and materials may be kept and personnel may work safely. Tourists will be kept outside of this buffer, both for their own safety and to allow workers to focus on the tasks at hand without having to manage visitors. The project foreman may at his discretion opt to temporarily stop work in the area and allow individuals or groups of 5 or fewer within the buffer to examine the work in progress; this is intended primarily as a way to accommodate local visitors and preservation professionals with a more focused interest in the site, rather than casual visitors who should be able to see enough from outside the buffer.

During restoration, the buffer will be marked with yellow construction tape tied to vegetation, and if necessary, to stakes. Should the work extend beyond the period of a single trip, the archaeologist and project foreman will evaluate the degree of completion, the stability of complete and incomplete sections, and decide whether
