**PRESERVATION PLAN FOR
SELECTED SITES AT NU'ALOLO KAI,
NĀ PALI COAST STATE WILDERNESS PARK
DISTRICT OF WAIMEA, KAUA'I**

**STATE OF HAWAII
DEPARTMENT OF LAND AND NATURAL RESOURCES
DIVISION OF STATE PARKS**

June 2007

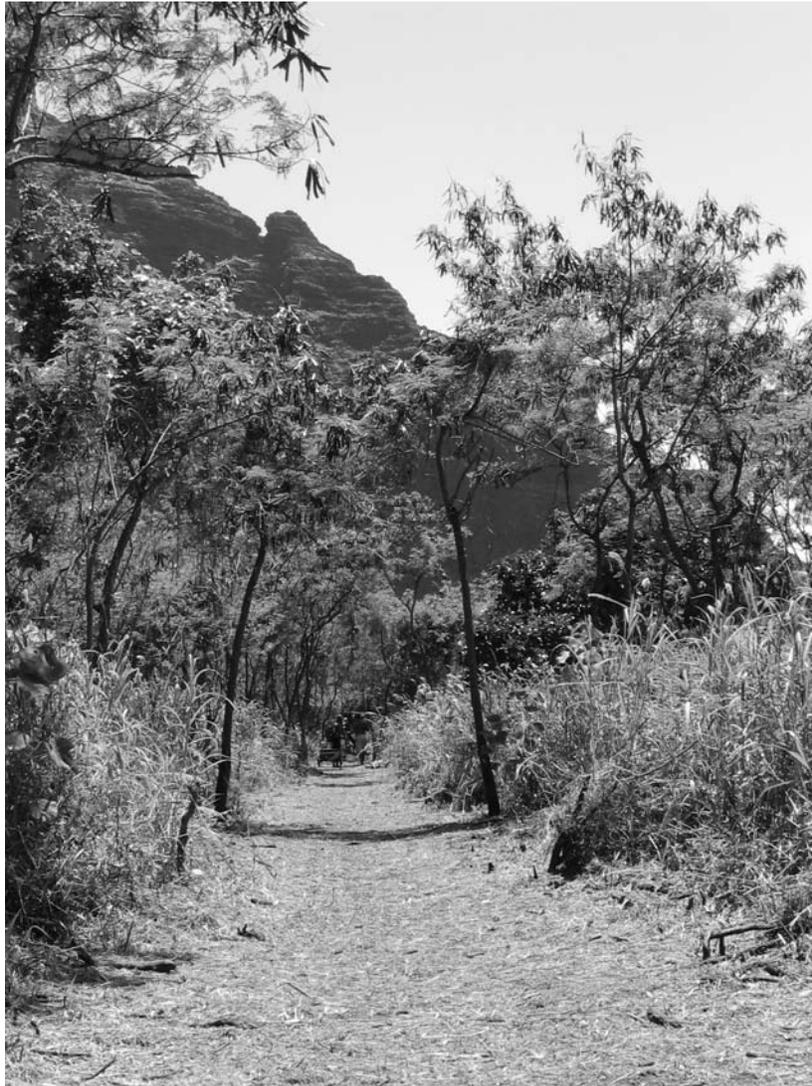
FIGURE 21. Clearing alone makes the trail easily identifiable in some areas.

For about a decade, an interpretive trail has been established and is in near daily use throughout the summer season. Vegetation clearing has been perhaps the most effective tool in establishing the trail route, and observation by archaeologists and Nā Pali Coast 'Ohana members confirms that very few people wander off of the cleared trail route into higher vegetation. In places where clearing extends beyond the trail corridor, such as the space between the trail and Makaleka's wall (Site 197A), use of tree trunks to provide a visual definition to the trail edge has proved effective as well. Though the distance varies, generally a 2-m interval between trail's edge and the closest surface feature accommodates close viewing while preventing damage.

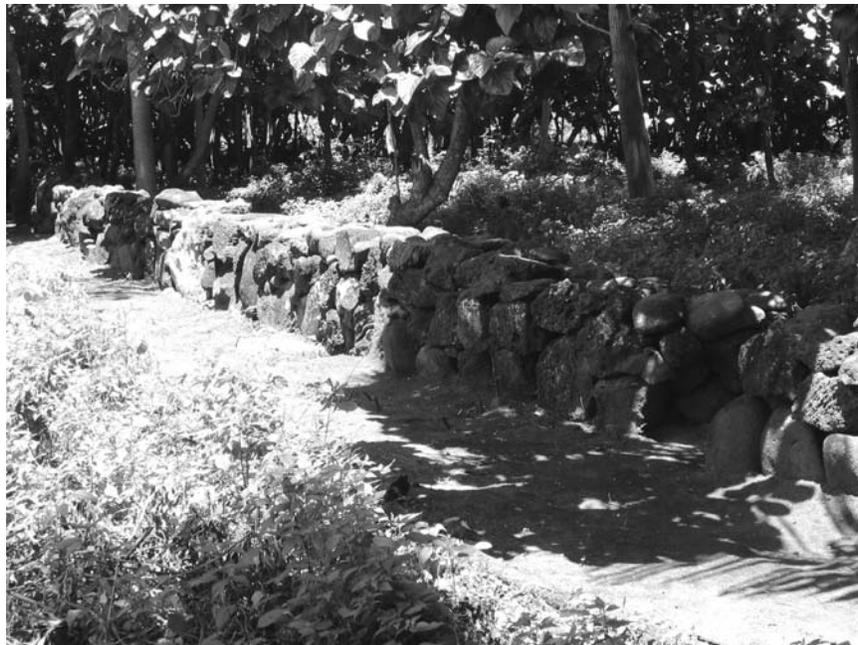
FIGURE 22. Site 197:A. The stabilized wall makes an effective trail edge.

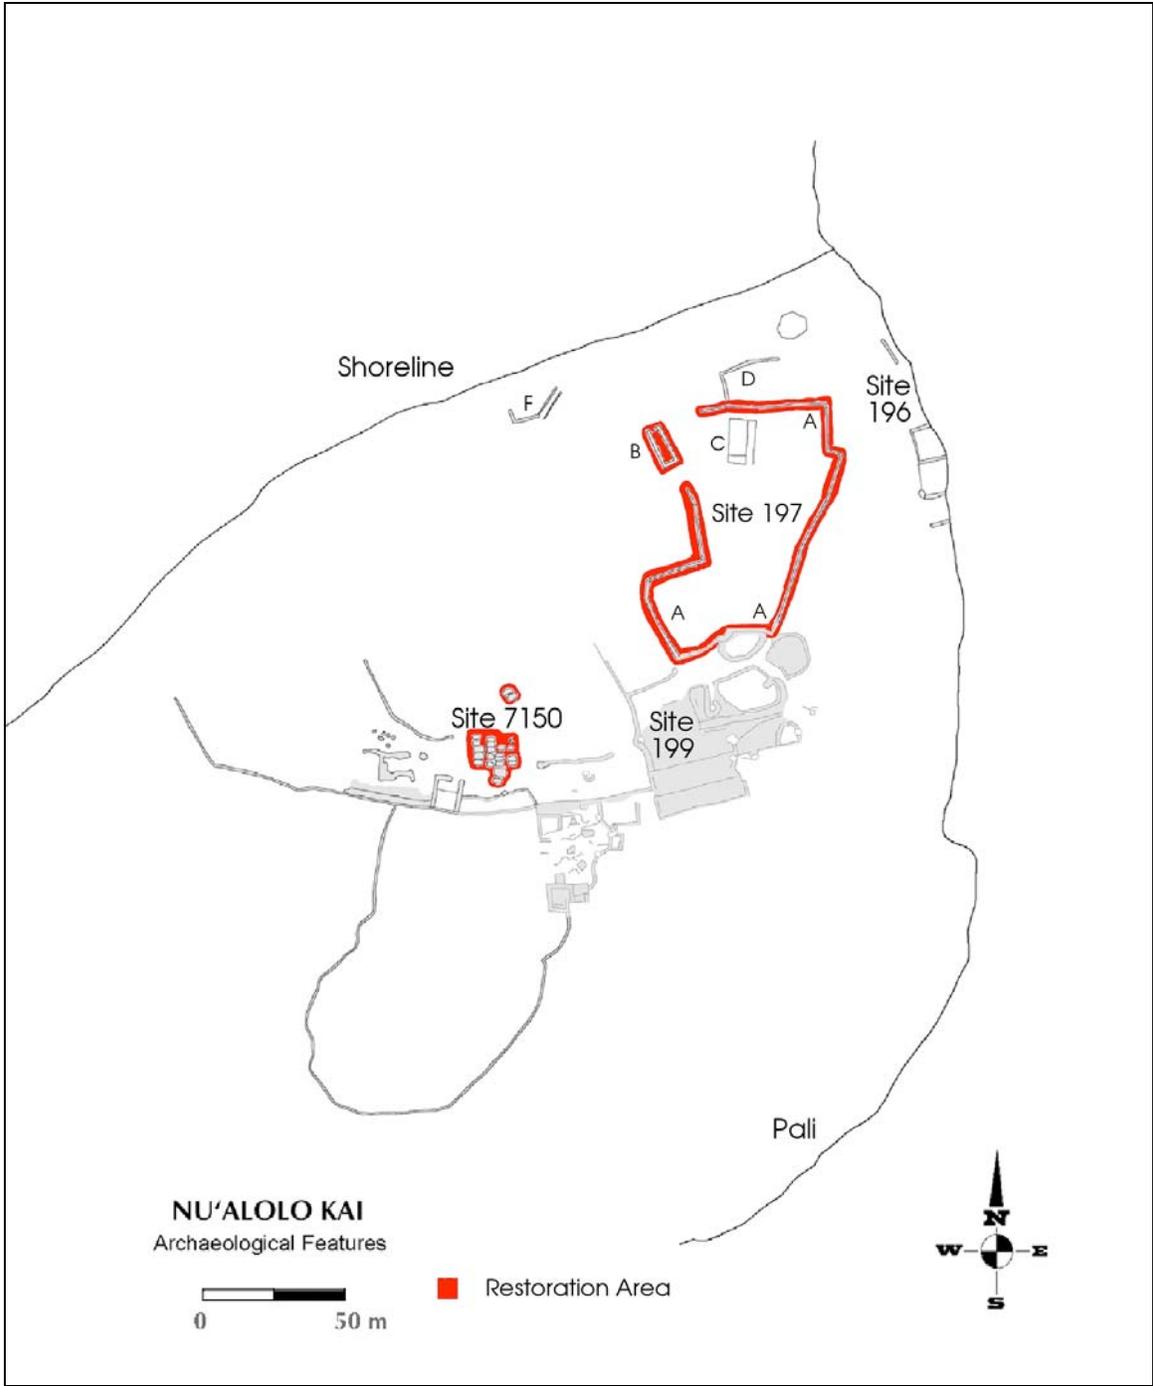
FIGURE 23. Area of proposed stabilization and restoration.

During the coming years, State Parks staff and volunteers will work to rebuild portions of Site 197 Feature A and all of Feature B, as well as the surface features of Site 7150; the areas involved are shown below in Figure 24. If additional areas are restored in the future, SHPD will be notified with a supplemental preservation plan.

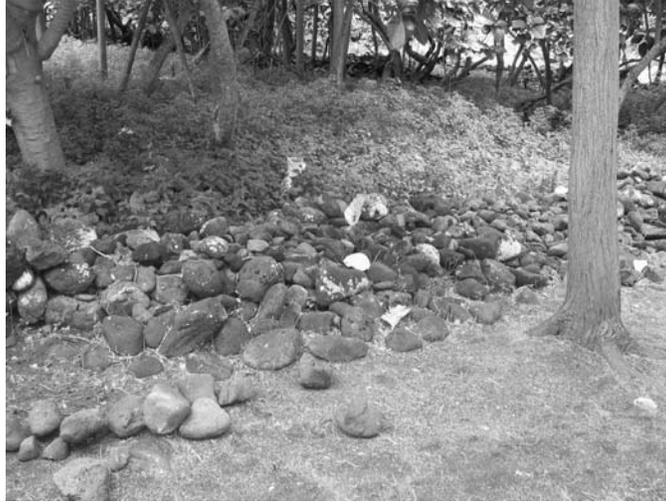
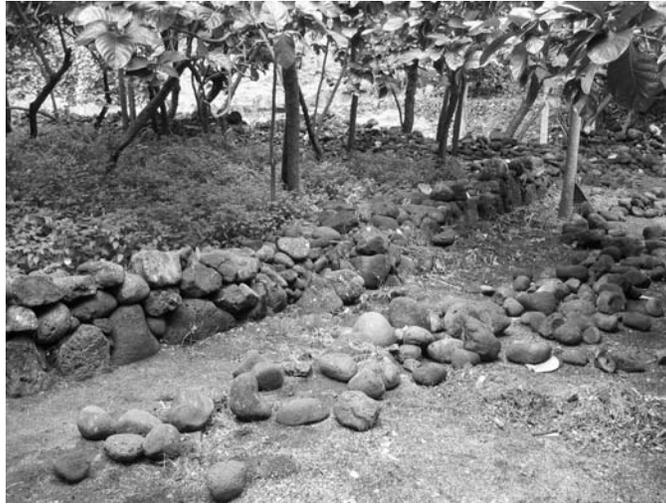
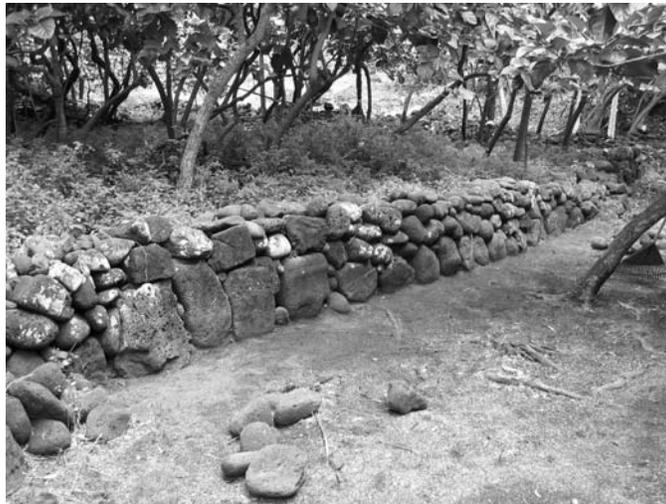
FIGURE 24. Site 197:A wall. Above, after clearing. Middle, rubble moved away from foundation. Below, repaired.

To help protect the cultural deposits around the features being stabilized and rebuilt, boards will be placed on the work surfaces surrounding them. Workers will walk on these to avoid churning up the soil. Stone will be removed down as far as it is loose and unconsolidated. In many cases, this will leave a wall base 2 or more courses high, but in some cases may consist only of a foundation.

Unless a foundation stone is obviously and extremely askew (greater than 10 degrees off vertical), it will not be moved. If it is, an archaeologist will collect and screen sediment that has to be removed. The most likely scenario for this would be if a slab needs to be re-set in a vertical position, and it is estimated that this would yield under 4 liters of sediment, and probably far less. Midden recovered during this process will be recorded in the field, and artifacts will be collected.

It appears that most or all of the original stones used to make this feature remain near the feature; furthermore, it appears that rocks remain along the section of wall from which they came, indicating simple collapse without much lateral displacement. Under guidance of the mason foreman, project staff will re-stack the wall using local material, without use of mortar or non-traditional means of stabilization. The default rule will be to use loose stone in the section of wall adjacent to it, moving stones laterally only where the mason and archaeologist reach a consensus that the stone has been displaced, and where such movement is required to maintain a relatively even finished height. In such cases, feature maps will be annotated to show the source, destination, and approximate quantity of stone moved. (Quantity likely can be expressed in number of large cobbles and boulders moved, but may also be reported in terms of volume if too large for a count.)

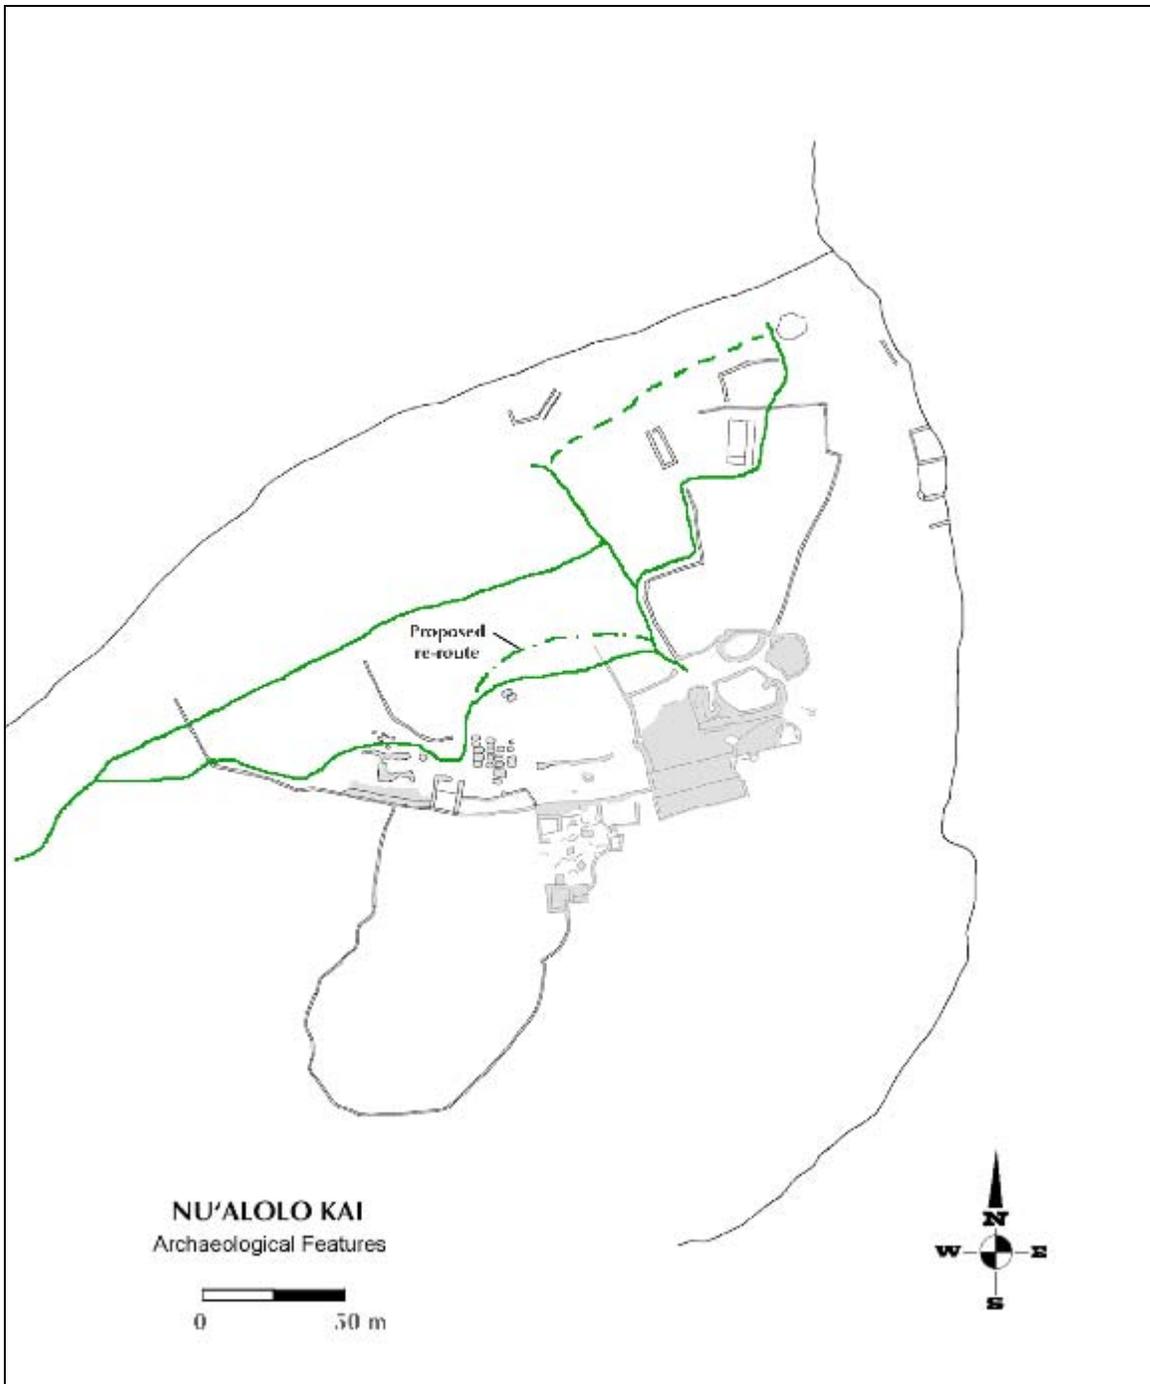
FIGURE 25. Interpretive trail route through Sites 7150 and 197.

Trail Alteration or Closure. Daily foot traffic through the flats, though limited by the remoteness of the area and the fact that permits are required to land, represents activity whose frequency and proximity to cultural sites makes it a primary source of concern for preservation. A few years ago, the original route of the interpretive

trail was cut short to avoid bringing people to the Site 196 terraces; although goats are the major source of damage there and the risk of injury from falling rocks was a major factor, the potential for people to cause damage to the sites also weighed in the decision. Likewise, a breach through the 197:A wall was closed recently, and the trail rerouted around it. Also, the proximity of the trail to a couple of burial platforms in Site 7150 caused a minor realignment in the interest of protecting those features.

Should future condition monitoring show that the trail is impacting deposits or features, additional rerouting may become necessary. Alternately, especially where lack of level terrain or dense archaeological features make realignment impractical
